# A WINDOW INTO EARLY VIRGINIA HISTORY

Colonial-era trash pits provide layers of history and a glimpse into life in the 17th century. But sometimes those glimpses are bigger than usual.

*By Bill Dancy*

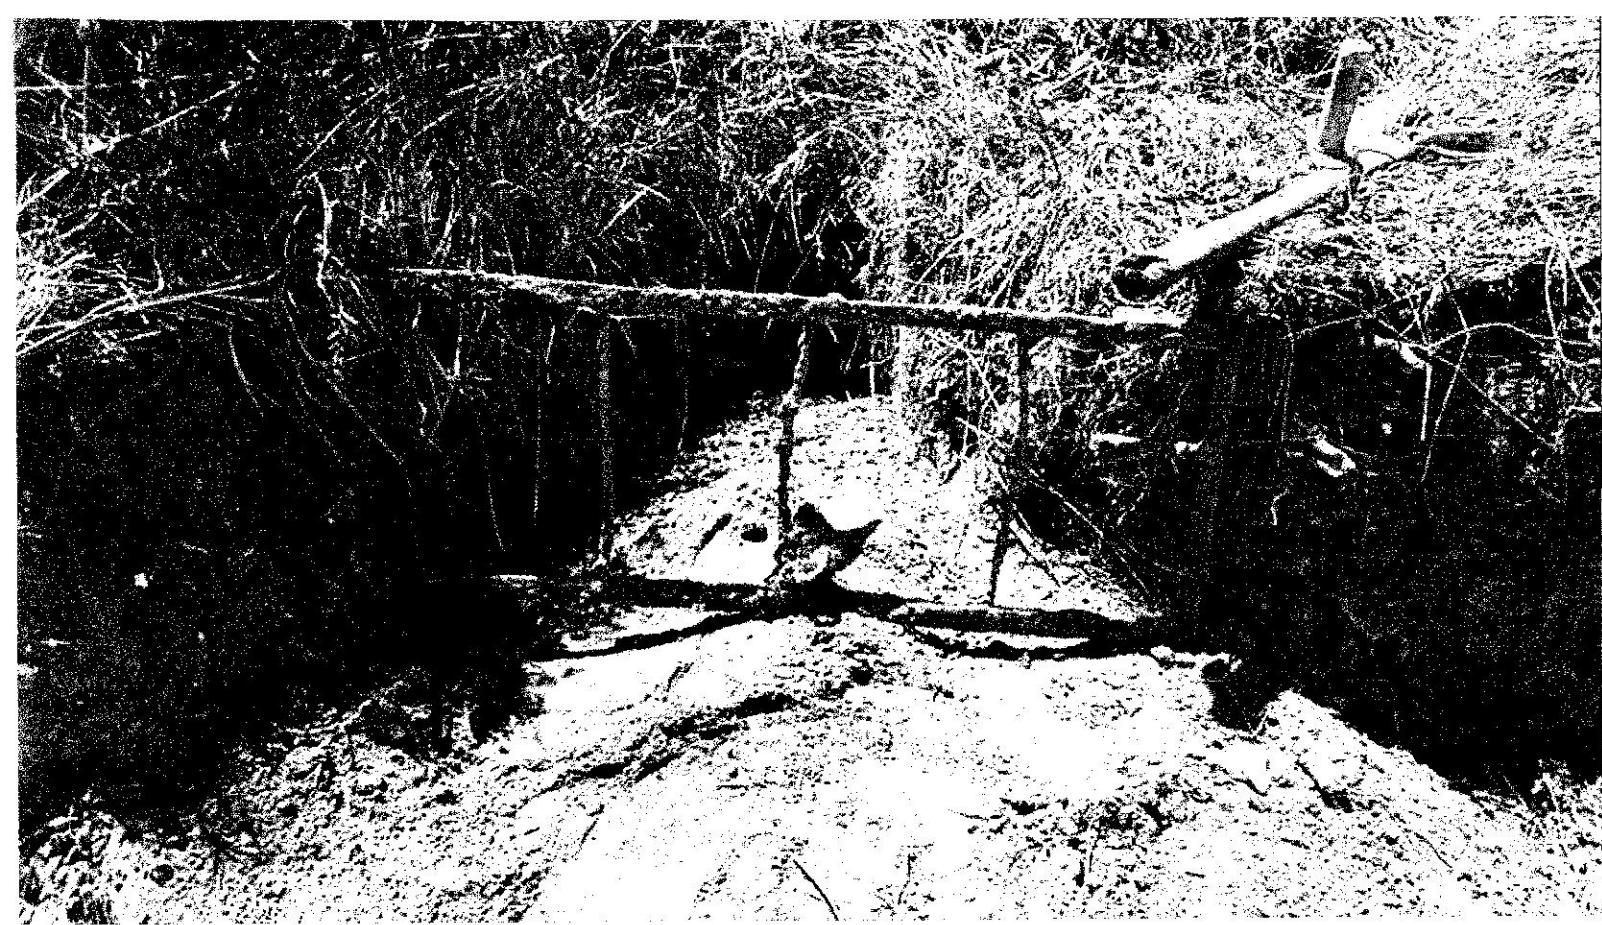
After a lengthy and difficult extraction, the mystery object in the trash pit turned out to be a complete 17<sup>th</sup> century casement window frame. It is shown in the above photo just after it was pulled from the ground. Only two other known examples have been recovered during archaeological excavations in Virginia, as shown below in the book, *Here Lies Virginia*, by Ivor Hume, 1963.

Once home I did a little research and quickly confirmed it dated to the late 17<sup>th</sup> century as it perfectly matched an example shown on a UK antique shop website. It was also found in the same context as other artifacts dating to this general period. The frame was heavily encrusted and I carefully used a small wire brush, putty knife, and Dremel tool to remove most of the loose surface corrosion, and then placed it in a large plastic tub to begin the long, slow process of electrolytic cleaning. After a full two months it was as clean as I could get it without risking eating away some of the base metal, although some stubborn spots of heavy corrosion could not be totally removed. After some final hand cleaning and thorough drying I applied four coats of polyurethane which will hopefully preserve it for at least a few years.

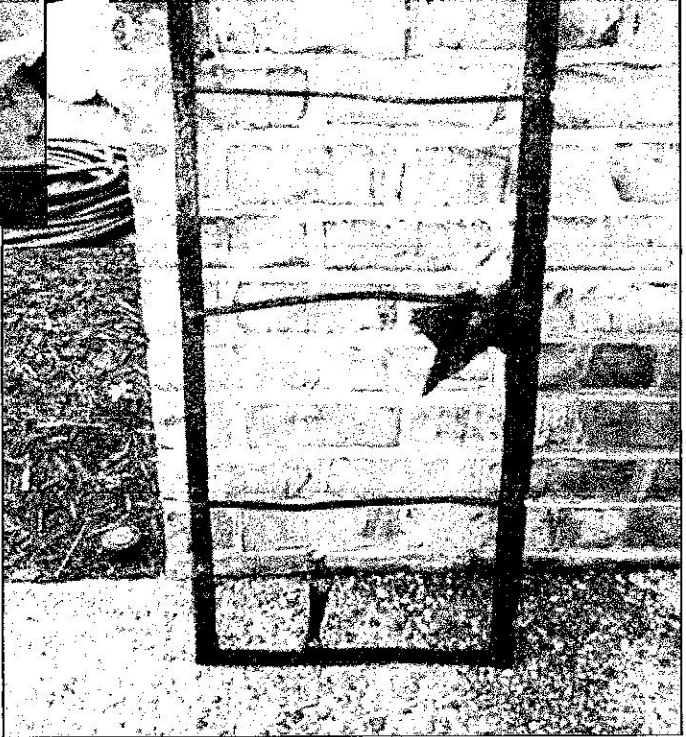
Once an iron object is removed from the ground, preservation must be started immediately. It took two full months to complete the electrolytic cleaning of the heavily encrusted frame utilizing a huge plastic tub, shown above. The results can be seen at right.

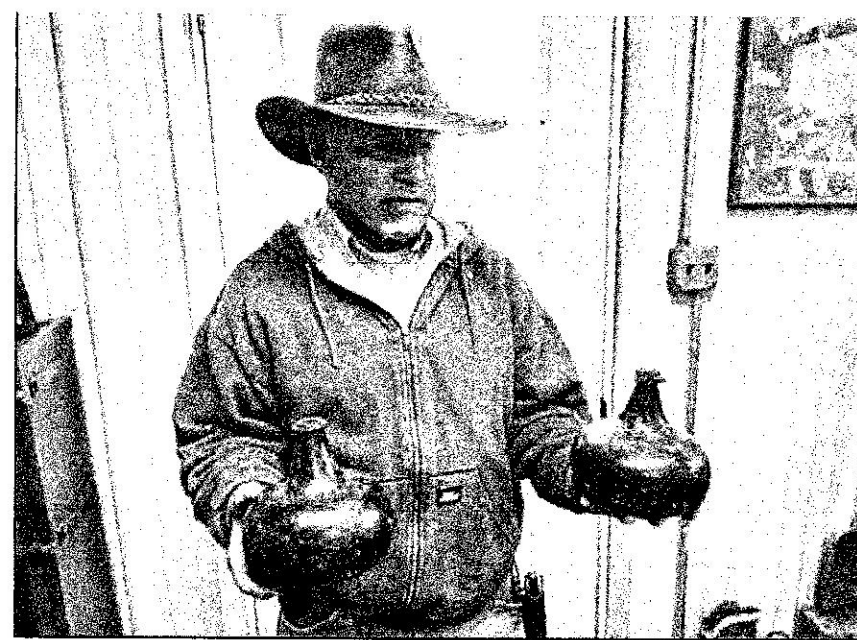
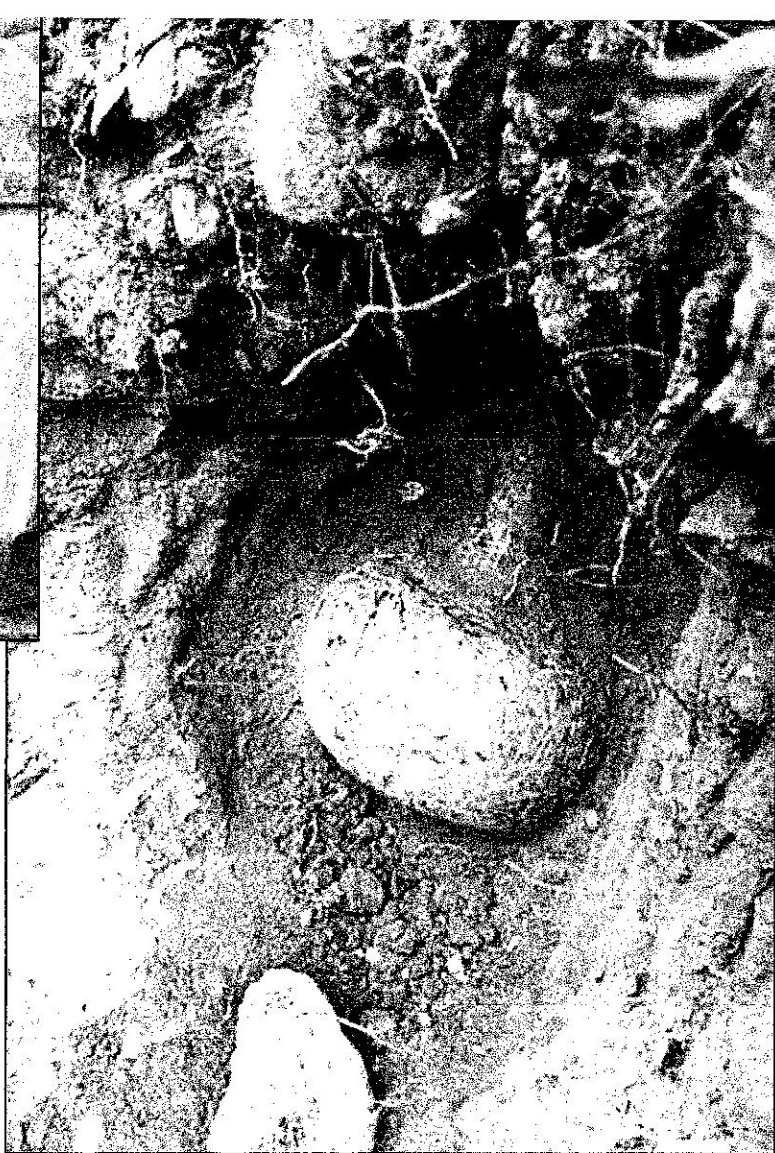
*While the window was the rarest find, it was not the only notable artifact to come from the site. The property farm manager, Ronnie Russell, found these two examples of early onion bottles that had washed out from the bank in the vicinity of the cellar floor. Careful digging revealed this amazing whole black glass onion bottle (right) in the cellar fill. On the following page is excavation of the site in progress. Pit digging is not for the physically unfit or lazy.*
